## A Novel Technique for Intraradicular Rehabilitation Using Mta and Light Transmitting Fibre Post: A Case Report.

**Keywords** - Intraradicular rehabilitation, light transmitting fibre post, MTA, flared canal

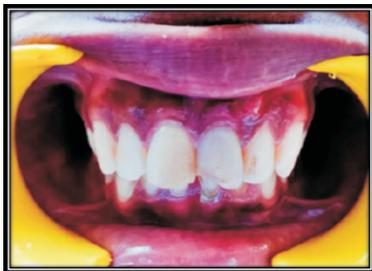
Fig 1 : Pre- Operative Clinical Picture

A 19 year old female patient reported to the Department of Conservative dentistry and Endodontics with the complaint of swelling in upper anterior tooth.History revealed a fall during her childhood. Clinical examination revealed discoloured and

fractured maxillary left central incisor [fig 1]. Swelling was fluctuant and tender on palpation. Intraoral periapical radiograph[fig 2] revealed irregular radiolucancy over 21 and 11. It also revealed incompletely formed apex as well as thin dentinal walls in apical region in relation to 21.

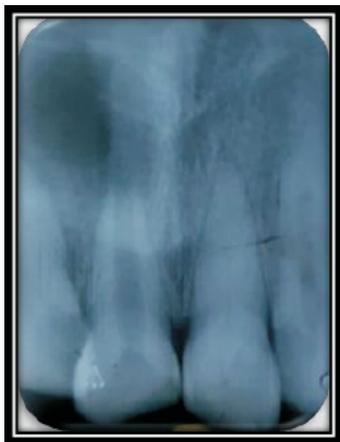
Fig 2: Pre-operative Radiograph Showing Blunder Buss Canal And Thin Radicular Dentin.

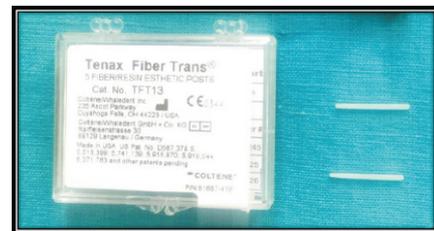
Fig 5 : Light Transmitting Fibre Post

A moist cotton pellet was placed over the MTA and access cavity was sealed with IRM. Patient was recalled after 24 hours. Tenax fibre trans light transmitting post (Coltene) were used for rehabilitation [fig 5]. Butt end of the fiber post was used in canal to build it with nanohybrid composite [fig 6]. Fiber post along with composite was taken out and cured and it was bonded into the canal using dual cure resin cement [fig 7]. Patient was then recalled after 3 weeks and a further follow up was maintained for 2 months.
